Fish Passage & Diversion Screening Inventory Database Report Cover Sheet

Site Description Report

Level A Culvert Assessment Report

Site ID:	04.0675 0.54				
Latitude:	48.45482612	Stream:	Rudd Cr	WRIA:	04.0675
Longitude:	-121.6100443	Tributary To:	Sauk R	Fish Use Potential:	Yes

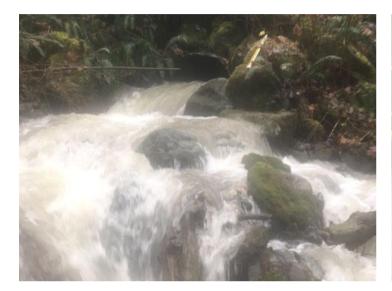
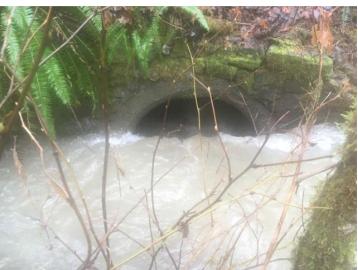
No plunge pool - flows directly onto large rip-rap. Concrete headwall at inlet. 1.83 m PCC at inlet, 1.68 m CST at outlet (CST for lower 6.5 m of pipe).
